**NASA
Technical
Paper
3190**

External Stress-Corrosion Cracking of a 1.22-m-Diameter Type 316 Stainless Steel Air Valve

Thomas J. Moore,
Jack Telesman,
Allan S. Moore,
Dereck F. Johnson,
and David E. Kuivinen

Lewis Research Center
National Aeronautics and Space Administration
Cleveland, Ohio, May 22, 1992

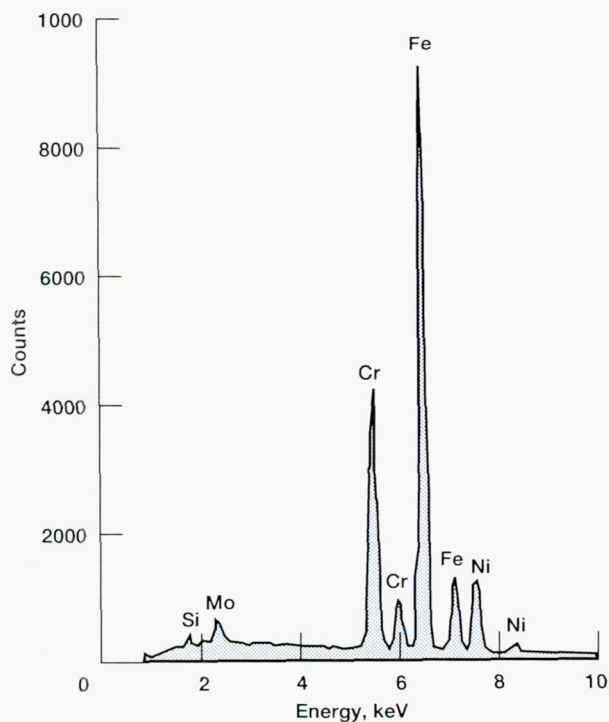
The base metal support ring spectra are shown in figure 15. A comparison of the support ring analysis as determined by XEDS and conventional methods can be made using the data in table I. This comparison shows general agreement except for the lower molybdenum (Mo) content in the XEDS analysis.

Figure 15.—Type 316 stainless steel matrix spectra.

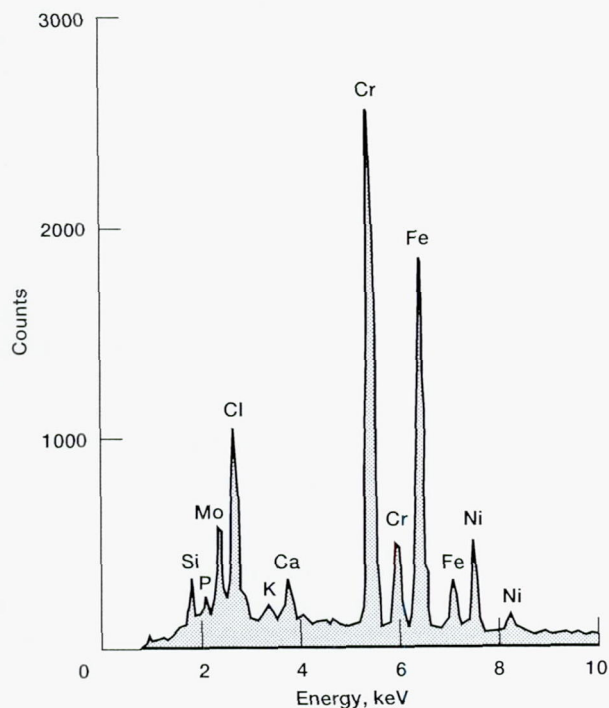
Perhaps the most important information was obtained from the analysis of the intergranular layer, 150 μm below the surface of the cracked ring (fig. 14). The profile for this spectra is shown in figure 16. These data are given in table I. A comparative XEDS analysis of the base metal and the intergranular layer showed increased quantities of Cr (18.5 to 31.1 percent), Cl (0.1 to 7.9 percent), and P (0.4 to 1.3 percent). The high Cr indicates the presence of chromium carbides at the grain boundaries (i.e., a sensitized condition). In this condition, the grain boundary regions adjacent to the

carbide particles are low in Cr and are thus susceptible to corrosive attack. The presence of a relatively large quantity of Cl is significant because of the key role this element plays in stress-corrosion cracking (SCC). The indicated increases in P and K may have resulted from the operational environment. Indications of higher Ca and Si are believed to be spurious, probably resulting from the plastic mounting material.

Figure 16.—Intergranular, stress-corrosion crack spectra.
